Proposed Residential Development at  
Site 10, Northern Cross, Malahide Road

Quality Audit

<b>Document Ref:</b>	<b>P22-088-UQA-GEN-RP-001</b>
----------------------	-------------------------------

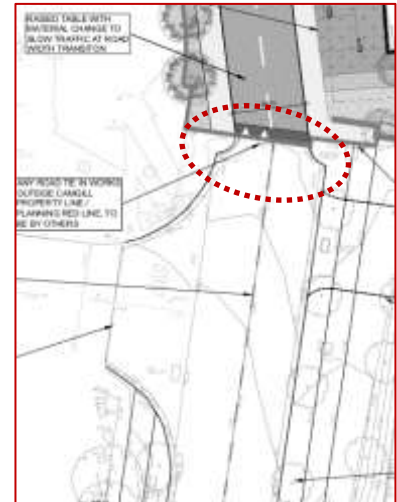
*Drawing:* Drawing no. BTNC-BMD-00-ZZ-DR-C-1020 (Rev. PL6)

*Summary:* Sudden reduction in carriageway width at south-western entrance to proposed development.

The proposed carriageway width on the internal road is narrower than the existing carriageway width immediately south of the entrance on the south-western corner of the proposed development.

The drawings provided indicate a relatively sudden narrowing at this location, which could present a hazard to northbound vehicles entering the site resulting in a vehicle mounting the kerb and striking a pedestrian within the footpath or to sudden avoidance manoeuvres leading to low-speed head-on collisions with vehicles exiting the development at this location.

During the design development the proposed road layout at this location should be amended to remove any sudden reduction in carriageway width at this location, so that there is a smooth transition between the existing carriageway and the proposed carriageway at this tie-in.

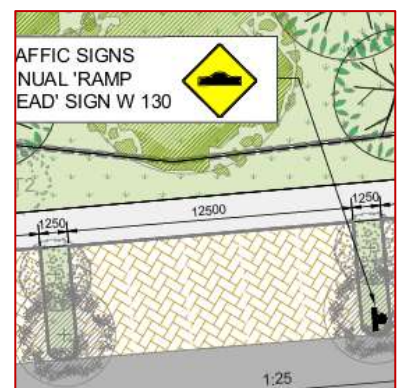
*Drawing:* Drawing no. BTNC-BMD-00-ZZ-DR-C-1020 (Rev. PL6)

*Summary:* The proposed location of trees may reduce inter-visibility between some road users.

Trees have been indicated within the islands adjacent to some of the parking spaces and at locations of proposed road signs.

It is unclear what type of trees are proposed at these locations, but should the canopy be too low it could impede visibility for drivers exiting from parking spaces towards approaching vehicles, or obscure the sign face resulting in drivers being insufficiently aware of the upcoming road layout.

Ensure trees are located outside visibility splays or that the tree type/species selected is such that it will not impede visibility or obscure signs.

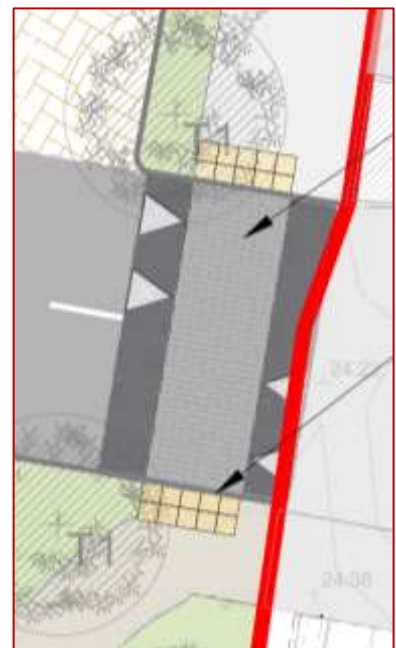
*Drawing: Drawing no. BTNC-BMD-00-ZZ-DR-C-1020 (Rev. PL6)*

*Summary: Tactile paving at in-line uncontrolled pedestrian crossing is not of the required depth.*

An uncontrolled pedestrian crossing of the internal road at the eastern boundary is proposed, on a raised-table.

The depth of the tactile paving indicated on the approaches to this crossing are insufficient for an in-line approach, possibly resulting in a visually-impaired pedestrian inadvertently stepping over the tactile paving and failing to recognise that they are entering a carriageway/crossing.

Tactile paving with a minimum depth of 1.2m, measured parallel to the direction of an approaching pedestrian, should be provided either side of the crossing.

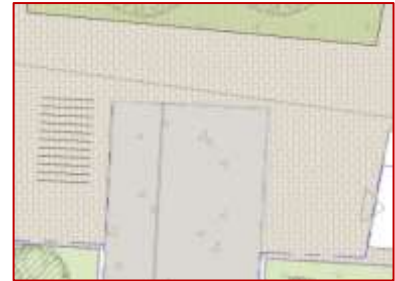
*Drawing: Drawing no. BTNC-BMD-00-ZZ-DR-C-1020 (Rev. PL6)*

*Summary: Potential for visually-impaired pedestrians to fall down cycle ramps in concourse area.*

A ramp is indicated between the residential development surface concourse area between the two blocks and the underground carpark. Visually impaired pedestrians may be insufficiently aware of the ramp, leading to trips and falls.

In addition, it is unclear what edge-protection measures are proposed around the ramp to prevent falls from height.

Measures should be provided to advise visually impaired pedestrians of the potential height hazard and edge protection provided to prevent falls from height.

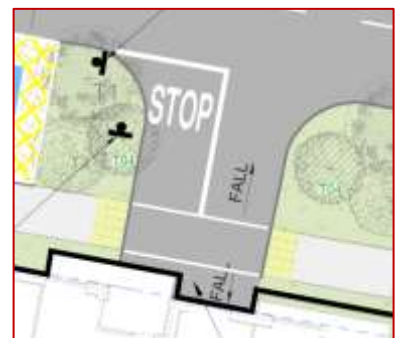
*Drawing: Drawing no. BTNC-BMD-00-ZZ-DR-C-1020 (Rev. PL6)*

*Summary: Intervisibility between drivers exiting the basement carpark ramp and pedestrians crossing the carpark access may be restricted by the boundary wall leading to an increased risk of vehicle-pedestrian collisions.*

An uncontrolled pedestrian crossing has been indicated across the access/egress to/from the basement carpark. It is unclear if there would be adequate inter-visibility between a driver exiting from the underground car park and a pedestrian approaching from the west towards the uncontrolled crossing of the car park access ramp.

Should there be insufficient inter-visibility, this could result in an exiting driver being unaware of a pedestrian about to commence a crossing, leading to possible vehicular/pedestrian collisions.

Adequate inter-visibility should be provided between drivers of vehicles exiting the underground car park and pedestrians approaching the uncontrolled pedestrian crossing of the car park exit ramp.

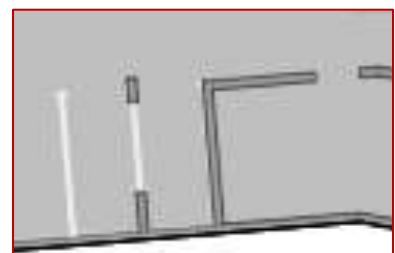
3.4.1 A number of the underground car parking spaces are indicated as possibly being narrower than 2.4m, as a result of structural element positions. In one case the parking space appears to be approximately 2.2m in width with a wall along one side.

Parking spaces of insufficient width can lead to difficulties for vehicle occupants entering/exiting the vehicle, leading to possible material damage upon entry/exit to the vehicle.
